## **Evaluating the Effect of Slab Curling on IRI for South Carolina Concrete Pavements**

**SPONSORED BY  
THE SOUTH CAROLINA DEPARTMENT OF TRANSPORTATION  
AND THE FEDERAL HIGHWAY ADMINISTRATION**

**COLUMBIA, SOUTH CAROLINA  
OCTOBER 2010**

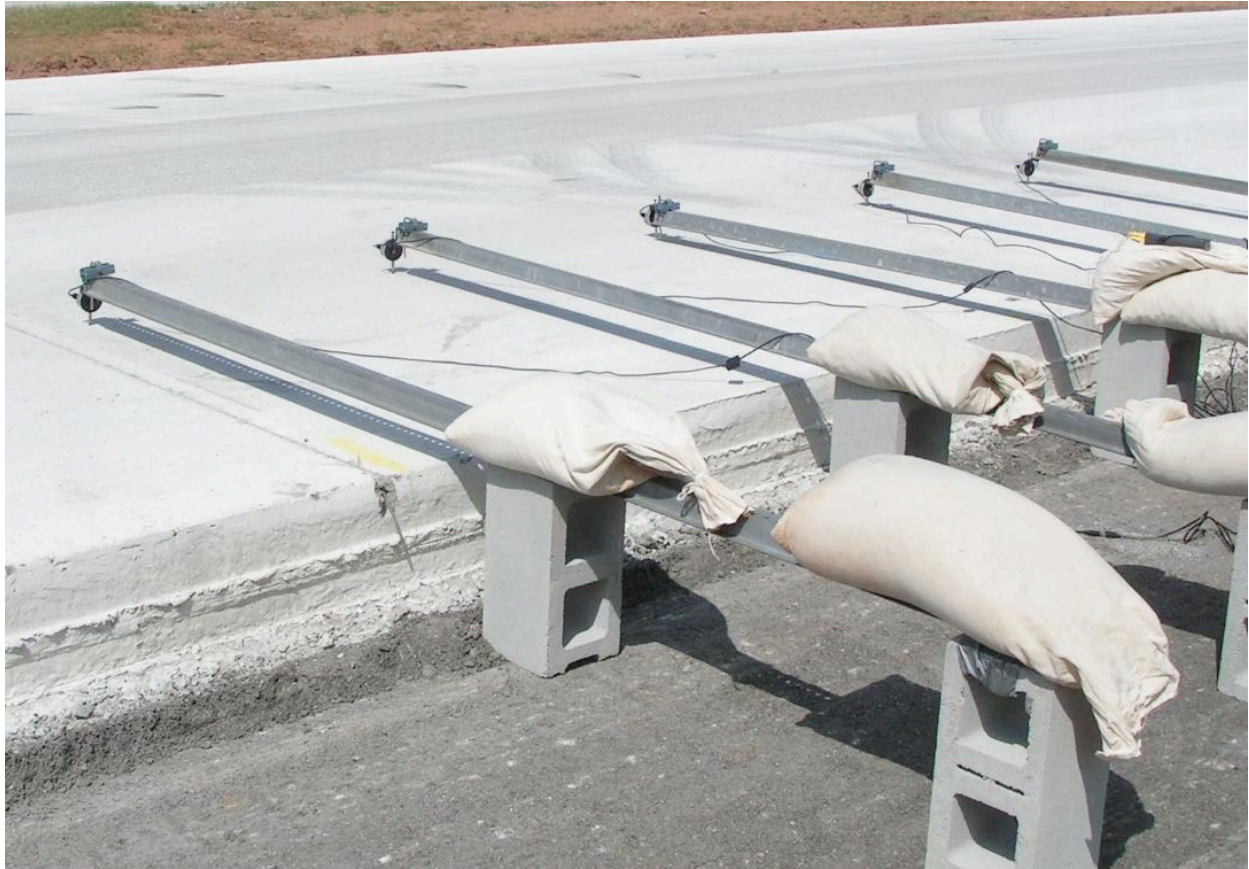
**Figure 1 Set-up of digital indicators at I-385 test site.**

As a part of a rehabilitation project, new jointed plain Portland cement concrete pavement was placed on I-385 in Laurens County. The test section of I-385 for this research project was located on the southbound direction near milepost 4. The data collection was performed over June 17-18, 2010, about two months after that section was paved. A test slab was selected in the outside travel lane. Five digital indicators were set up on the right wheel path of the test slab for the I-385 data collection. The gauges were linked to a computer to automatically record readings at a one minute interval. The scanner was placed on the outside shoulder and the profiler was run on the inside passing lane. Measurements were made with the terrestrial laser scanner and high-speed profiler at hourly intervals beginning at 1 PM. Figure 1 shows a picture of the set-up used for the digital indicator gauges to measure elevation changes at multiple points along a slab at the I-385 test site.
